TRANSPORTATION SAFETY

REFLEXIONS

Issue 17 – Winter 2001

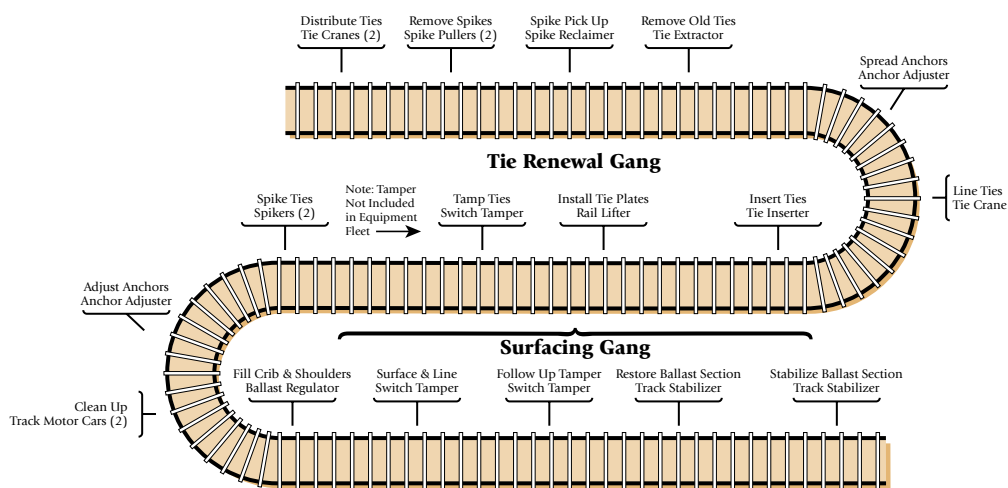
Schematic showing sequence of events for tie renewal and follow-up surfacing gang.

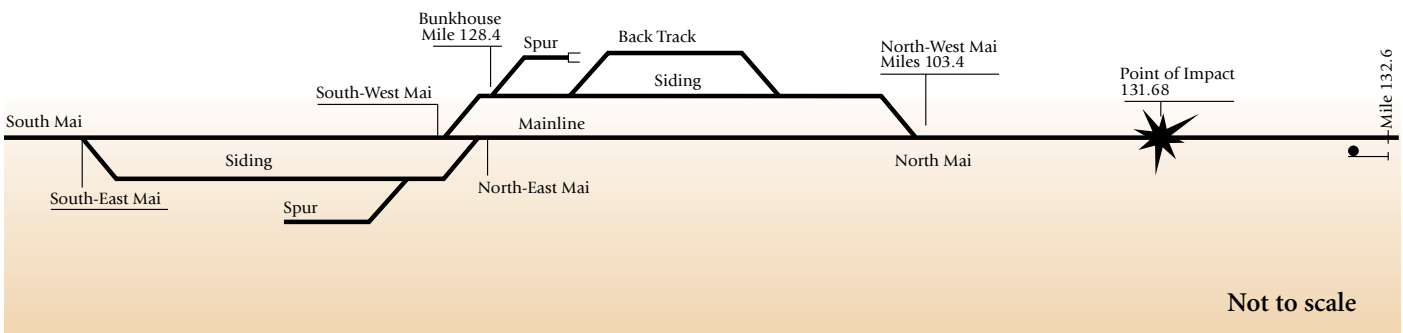
Diagram shows track layout at the occurrence site. Point of impact was one mile past the point where train 45 accepted a restricting signal indication.

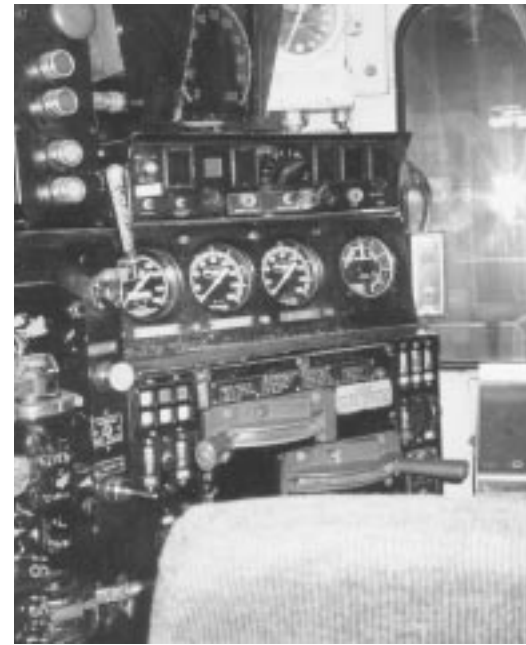
Control stand in the locomotive engineer's operating compartment of a QNS&L locomotive.

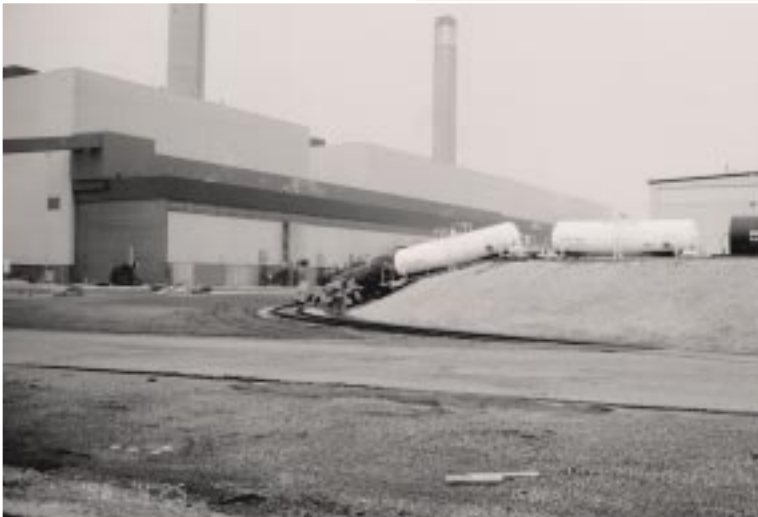
A failed attempted coupling, with a derail in the non-derailing position, resulted in the runaway of five dangerous-goods tank cars.

On 24 April 1996, a Canadian National (CN) train crew was switching at the Esso oil refinery near Nanticoke, Ontario, Mile 0.0 of the CN Hagersville Subdivision. Lacking a run-around track, the crew resorted to a roll-by manoeuvre in order to relocate the engine from the south end to the north end of a cut of 11 cars. The crew pushed five tank cars up a 1% ascending grade, coupled them to six other tank cars, ran the locomotive into another track, then let the cars roll past the locomotive, using hand brakes to stop the movement. When the locomotive was coupled to the north end of the cars and an unsuccessful attempt was made to charge the train line, the crew discovered that the five south cars were missing.

The derail had been left in the non-derailing position by another crew, which had switched the spur two days earlier. Several notices had been posted in the operating crew bulletin book at the Brantford crew office pertaining to the handling of derails in the Brantford area. In the previous 12 months, Transport Canada safety inspectors had issued two notices regarding the mishandling of derails in 13 observed instances in southwestern Ontario.
